**Three Year  
Asbestos  
Re-Inspection  
Report**

**New Branches Charter Academy  
3662 Poinsettia Avenue, SE  
Grand Rapids, Michigan 49508**

**Dated:  
October 9, 2015**

**Project No. 150264**

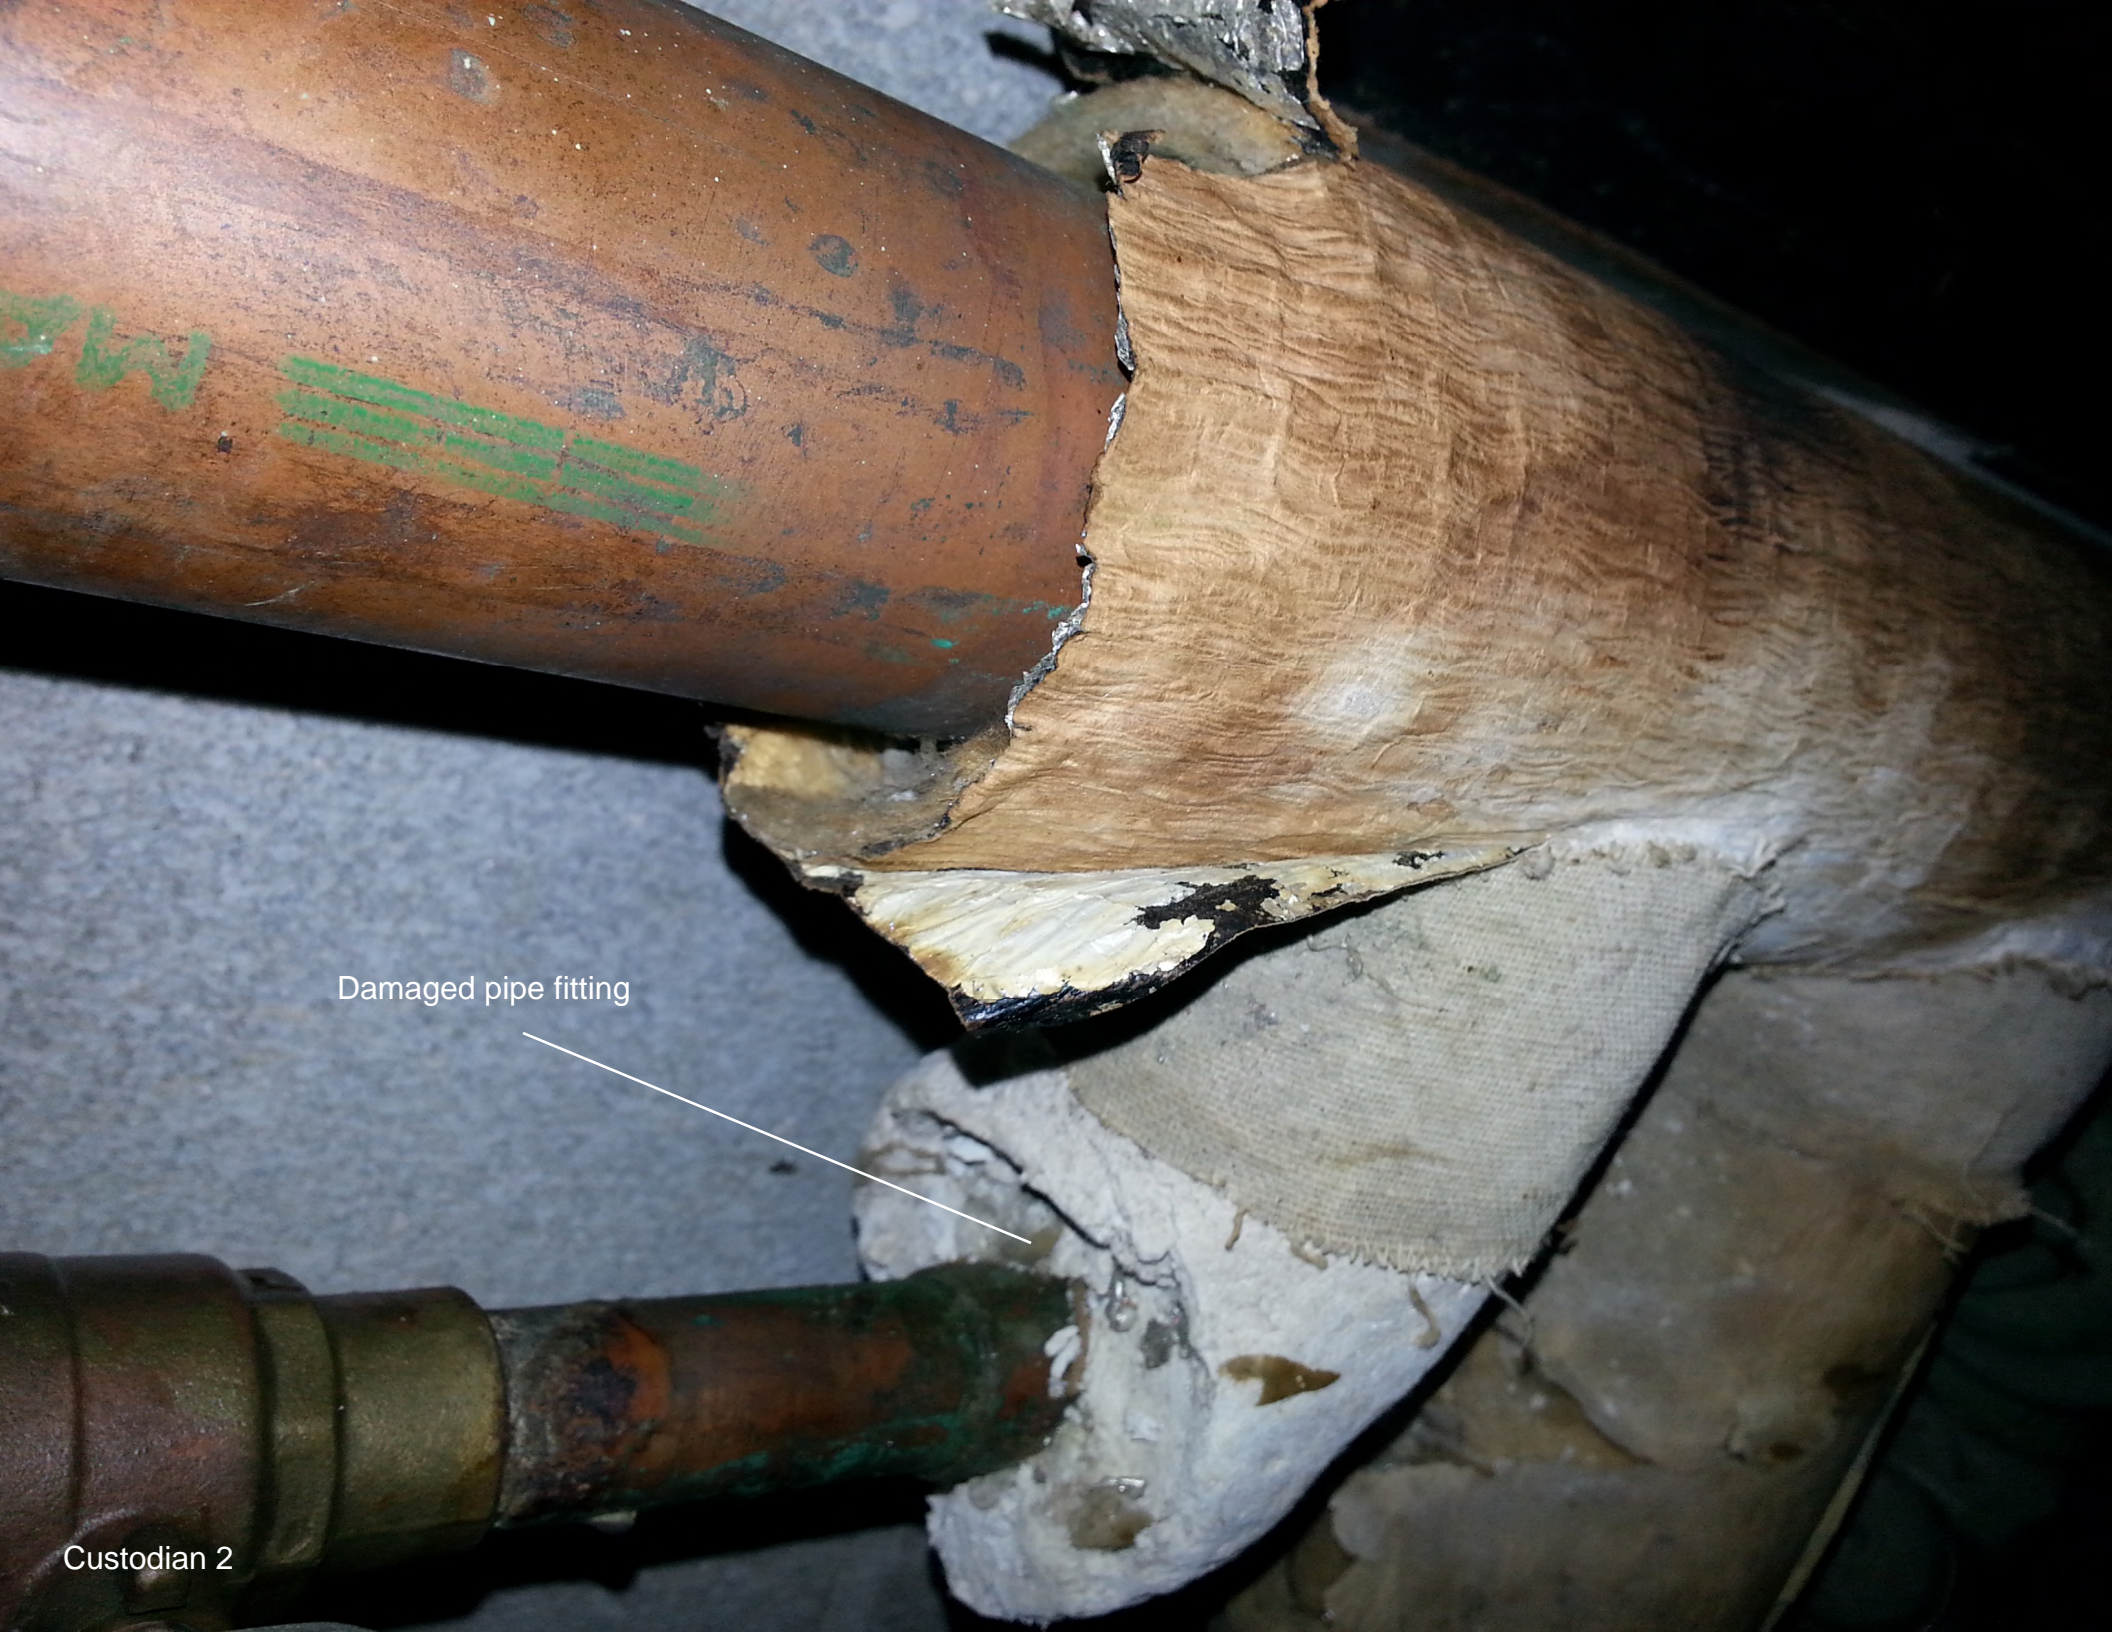
Damaged pipe insulation

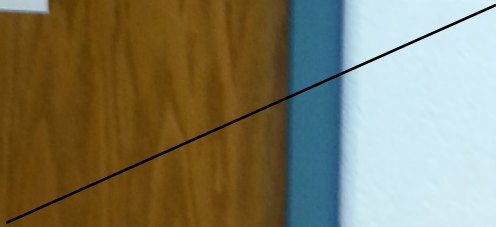
Damaged fire door needs repaired

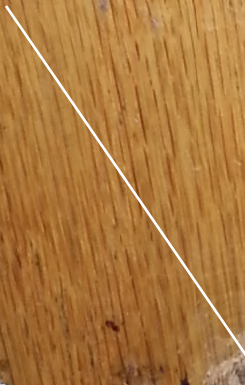
Damaged fire door needs repaired.

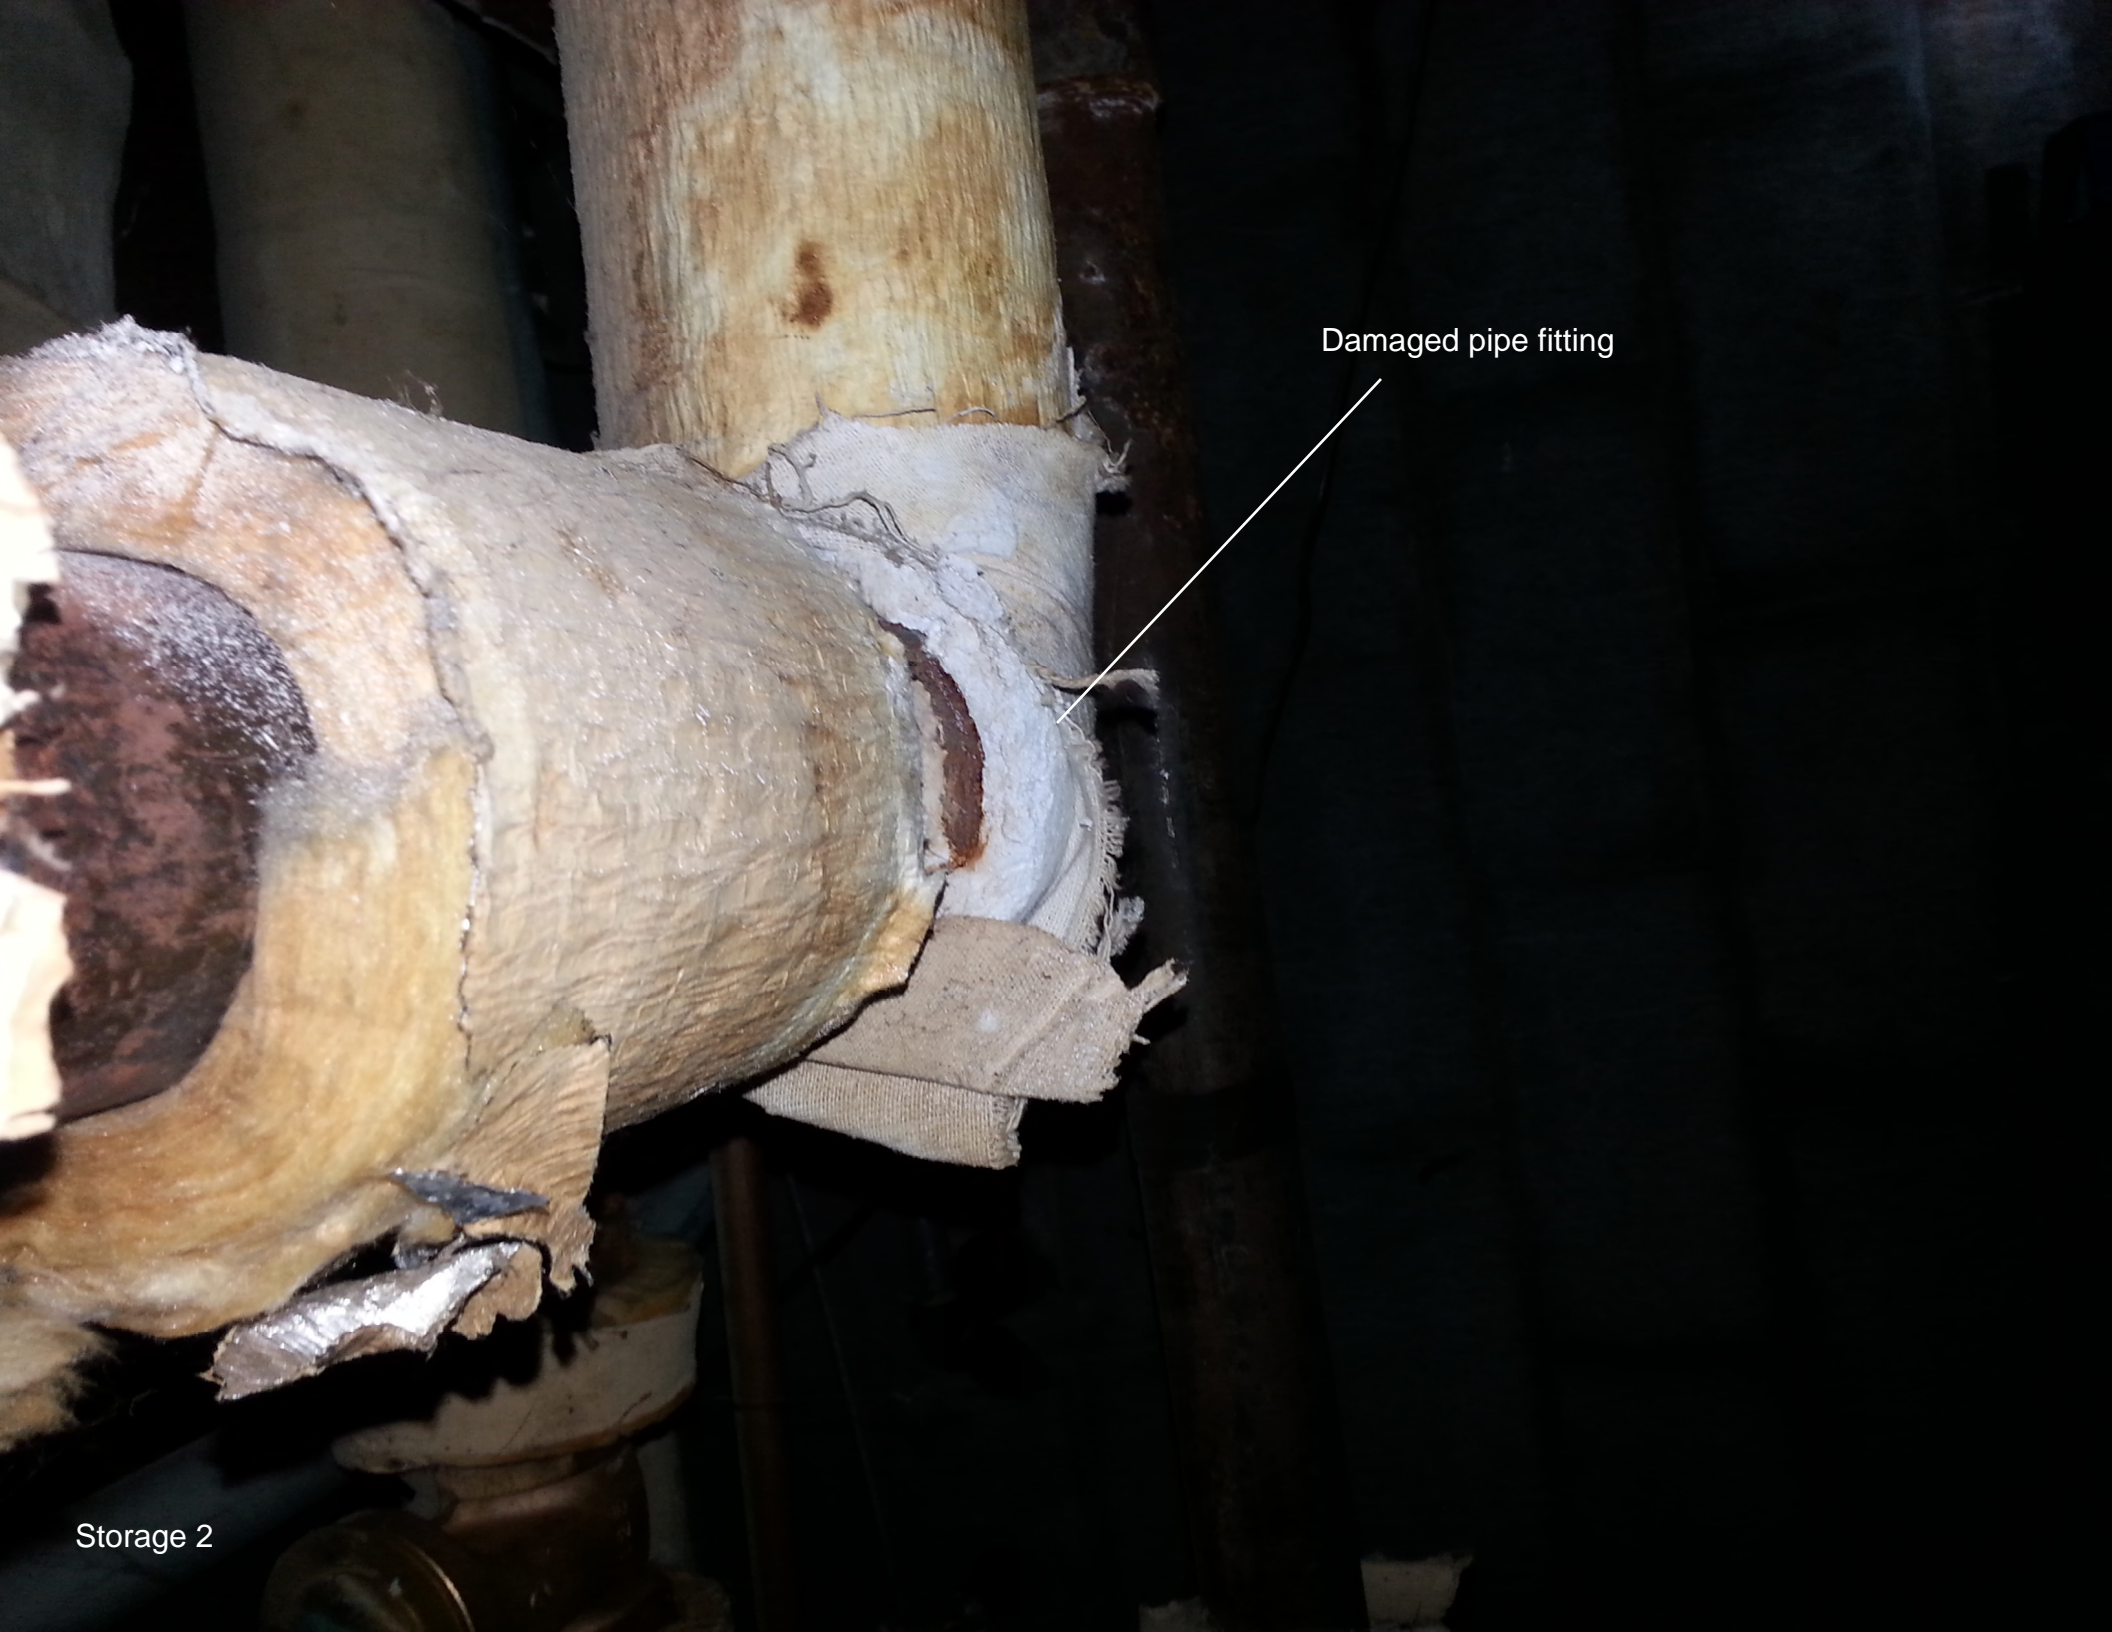
Damaged pipe fitting
